Facility Name: Swift – Bayou Chaland
City: Parish:
Date: 3/13/08 Reason: Oil Spill

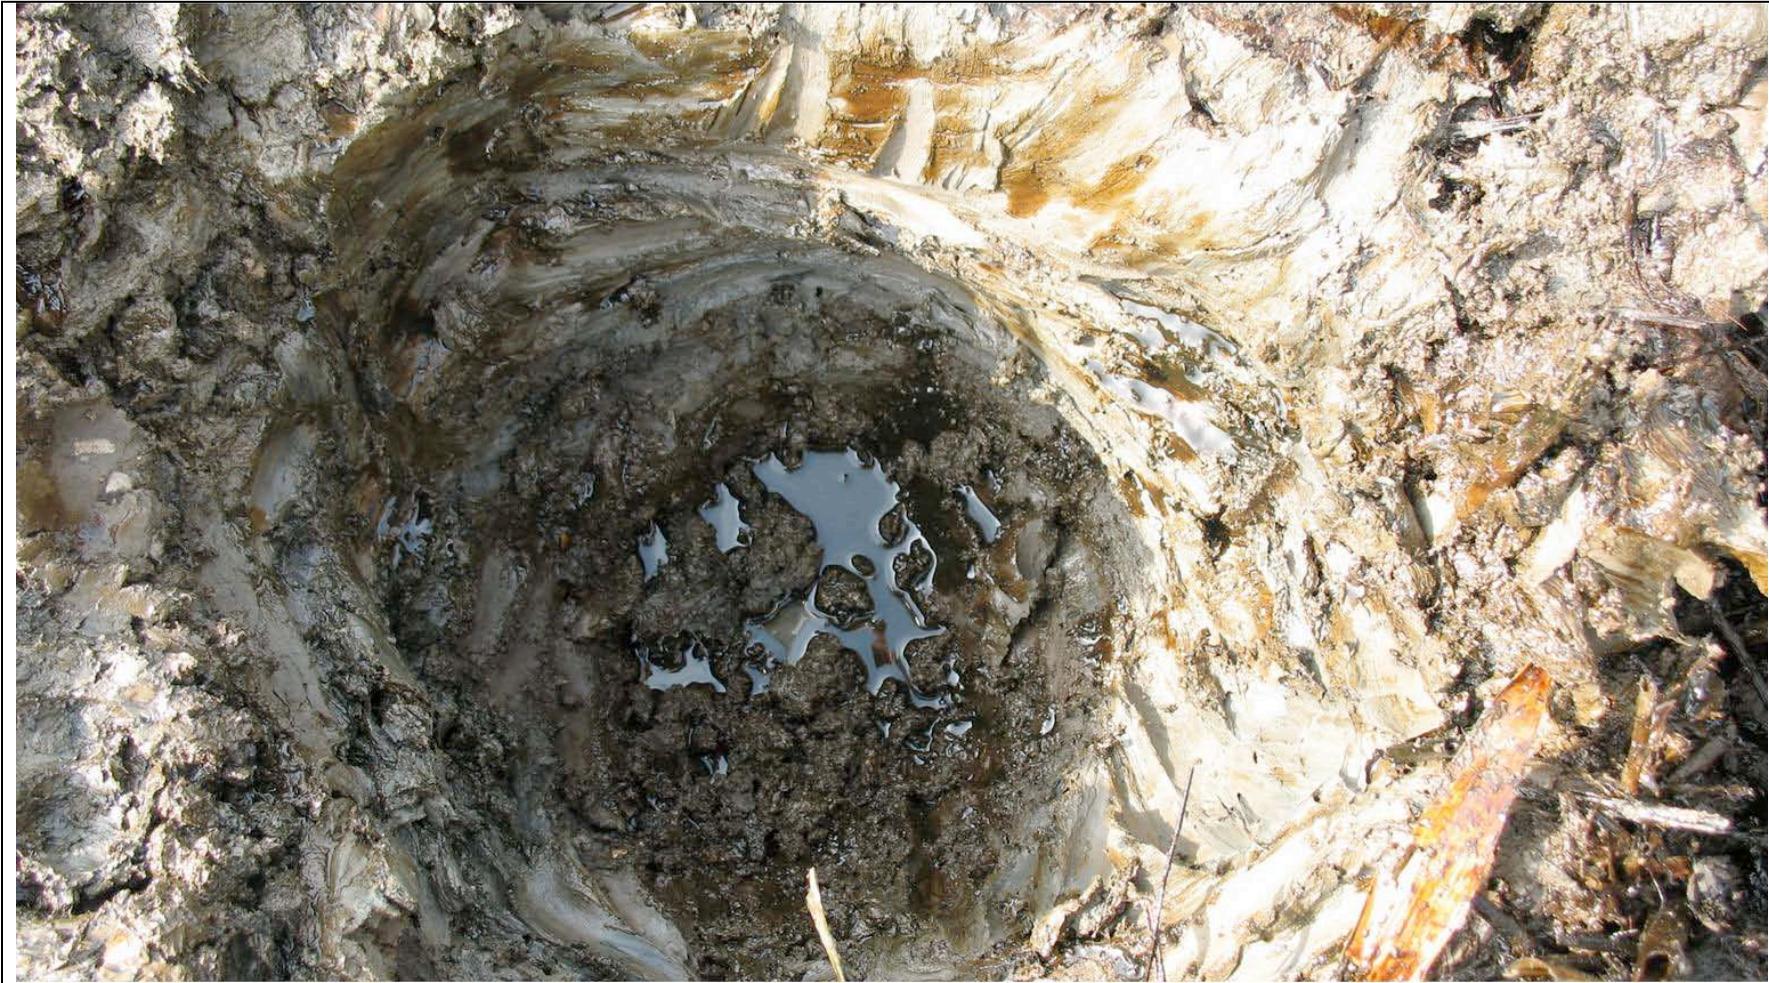
Photo #: 1 of 6

Description: (See Site X on Map #2) This hole was dug approximately 5' from the source at a depth of <1.5'. The photo was taken <1 minute (9:39 am) after the hole was dug using a spade and the sidewalls scraped with a gloved hand. Oil was observed draining from various veins through the sidewalls approximately 6"-8" from the surface. A peat-like layer of fibrous organics appears to exist below the clay/silt sediments and appears to be heavily saturated with oil.

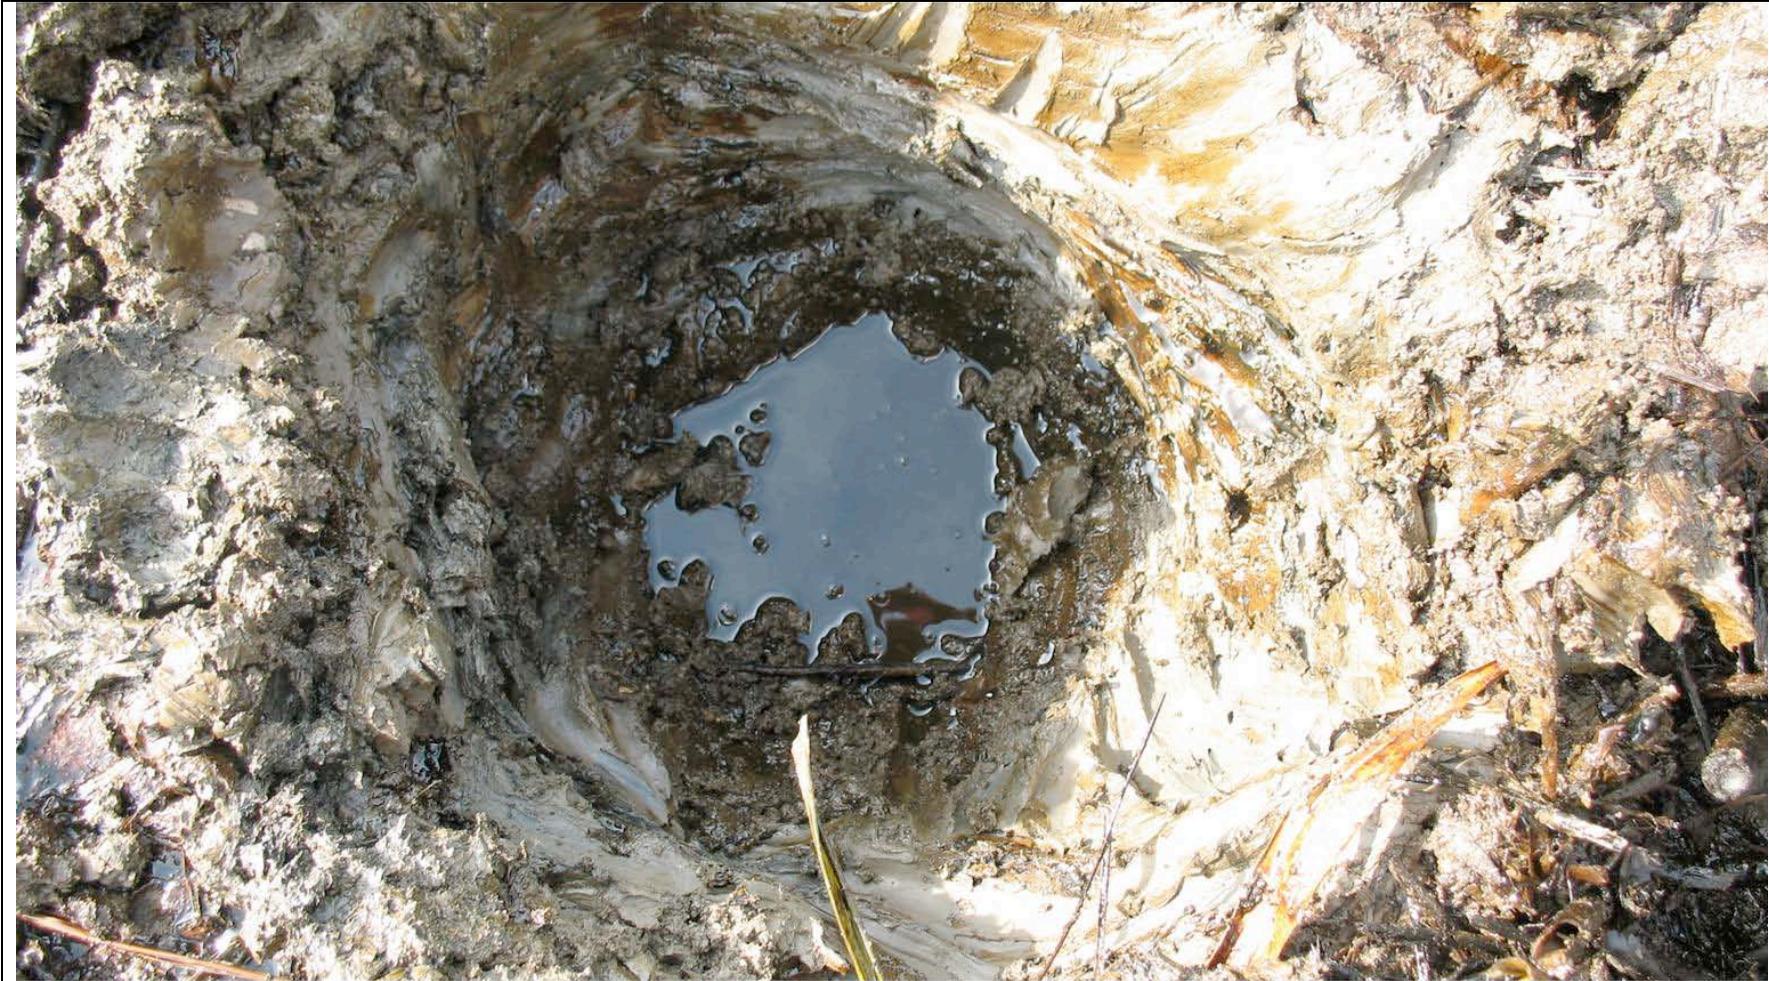
Photo #: 2 of 6

Description: (See Site X on Map #2) The same hole from photo #1, but the photo was taken <3 minutes (9:41) after the first. The bottom of the hole had begun to fill-up with oil as it drained from various veins through the sidewalls and from the fibrous organic layer below.

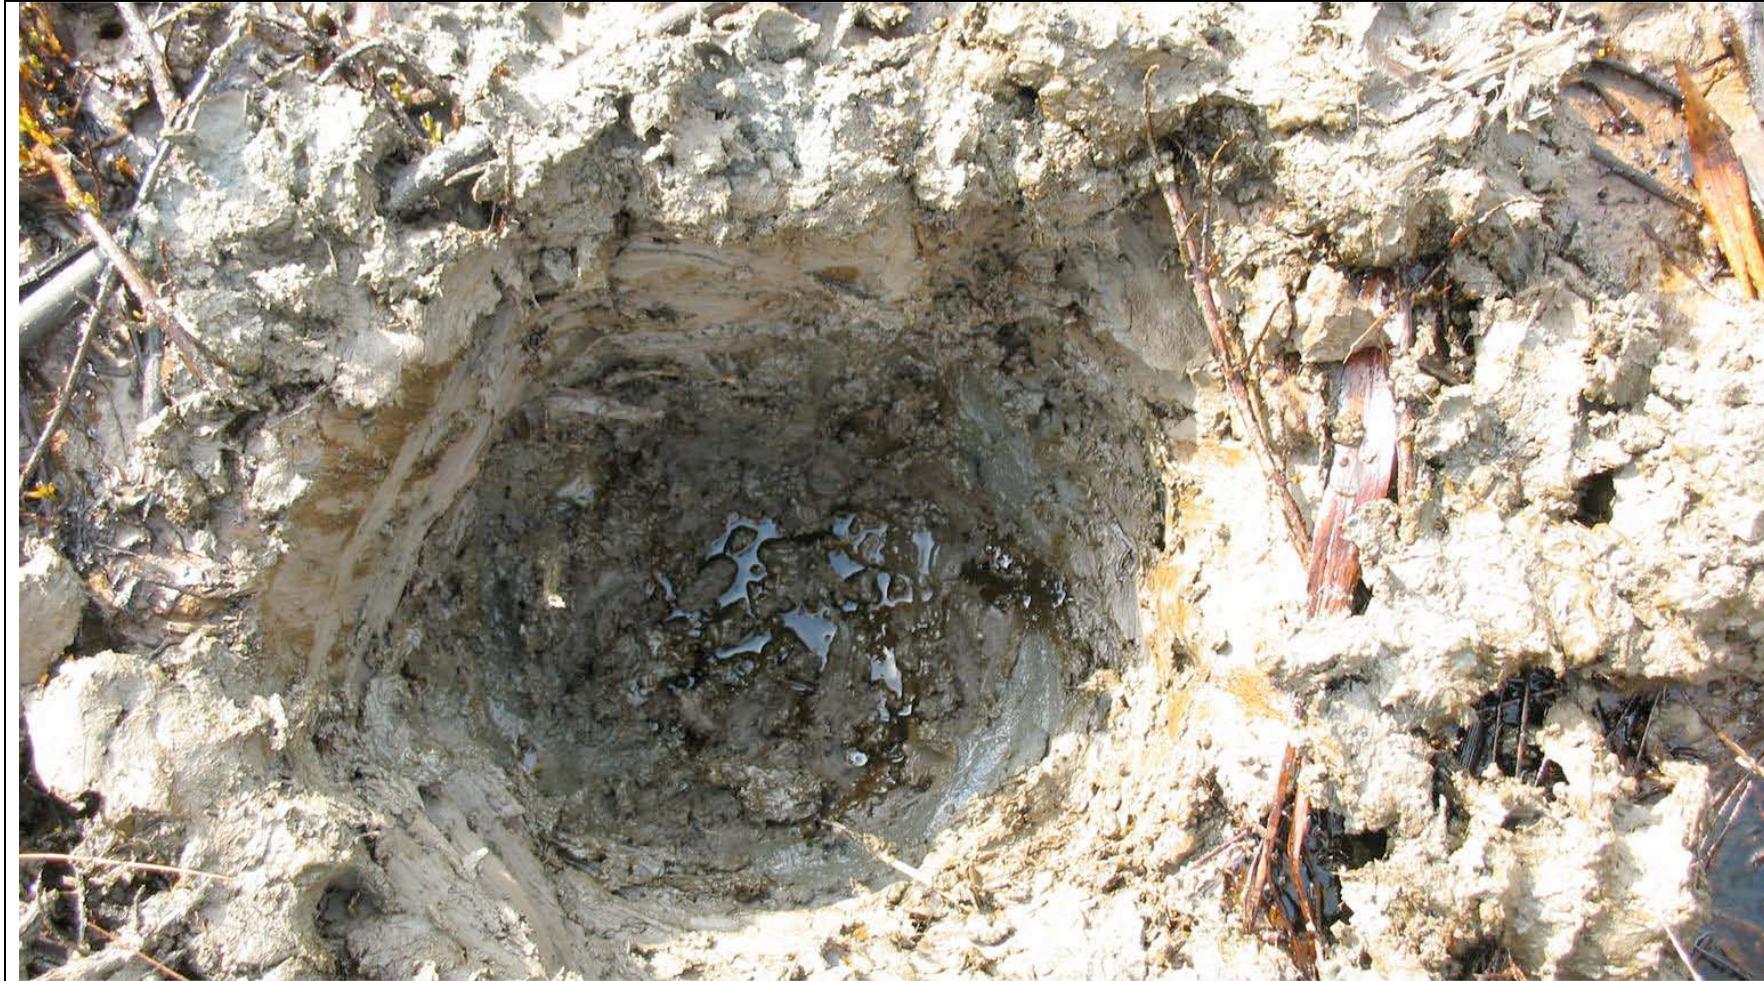
Photo #: 3 of 6

Description: (See site Y on Map #2) This hole was dug approximately 20' from the source at a depth of <1.5'. The photo was taken <1 minute (9:43 am) after the hole was dug using a spade and the sidewalls scraped with a gloved hand. Oil was observed draining from various veins through the sidewalls approximately 6"-8" from the surface. A peat-like layer of fibrous organics appears to exist below the clay/silt sediments and appears to be moderately saturated with oil.

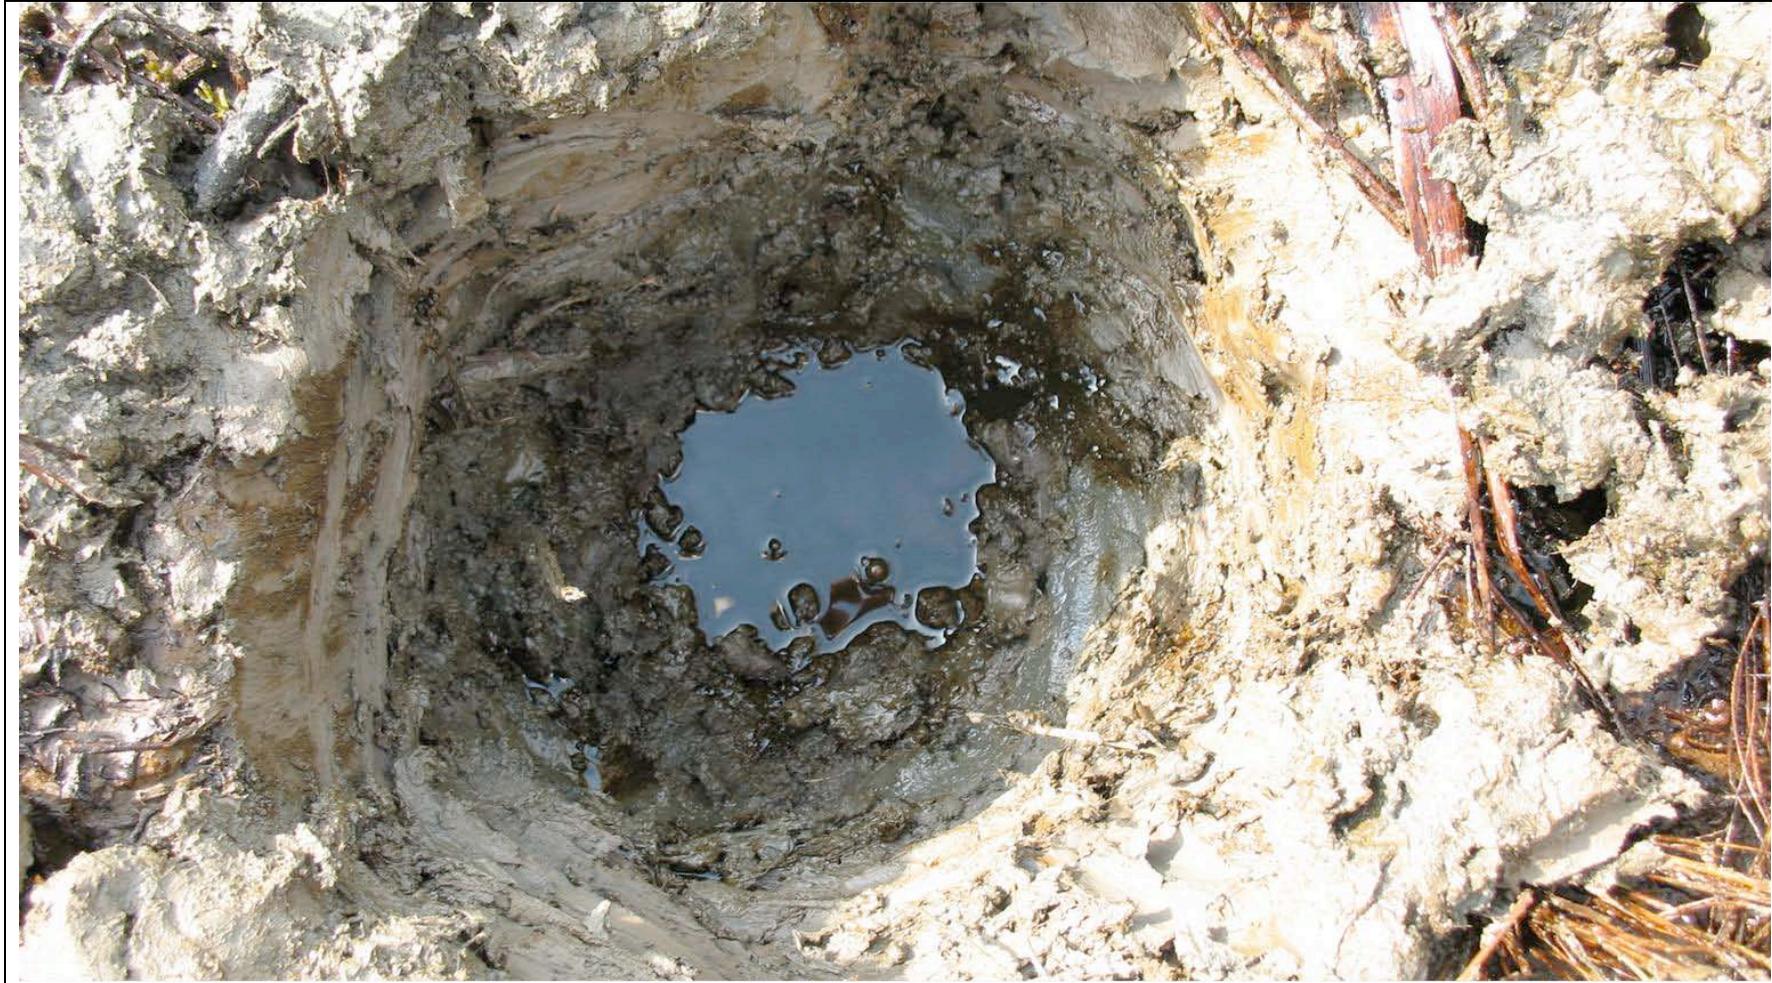
Photo #: 4 of 6

Description: (See Site Y on Map #2) The same hole from photo #3, but the photo was taken <3 minutes (9:45) after the first. The bottom of the hole had begun to slowly fill-up with oil as it drained from various veins through the sidewalls and from the fibrous organic layer below.

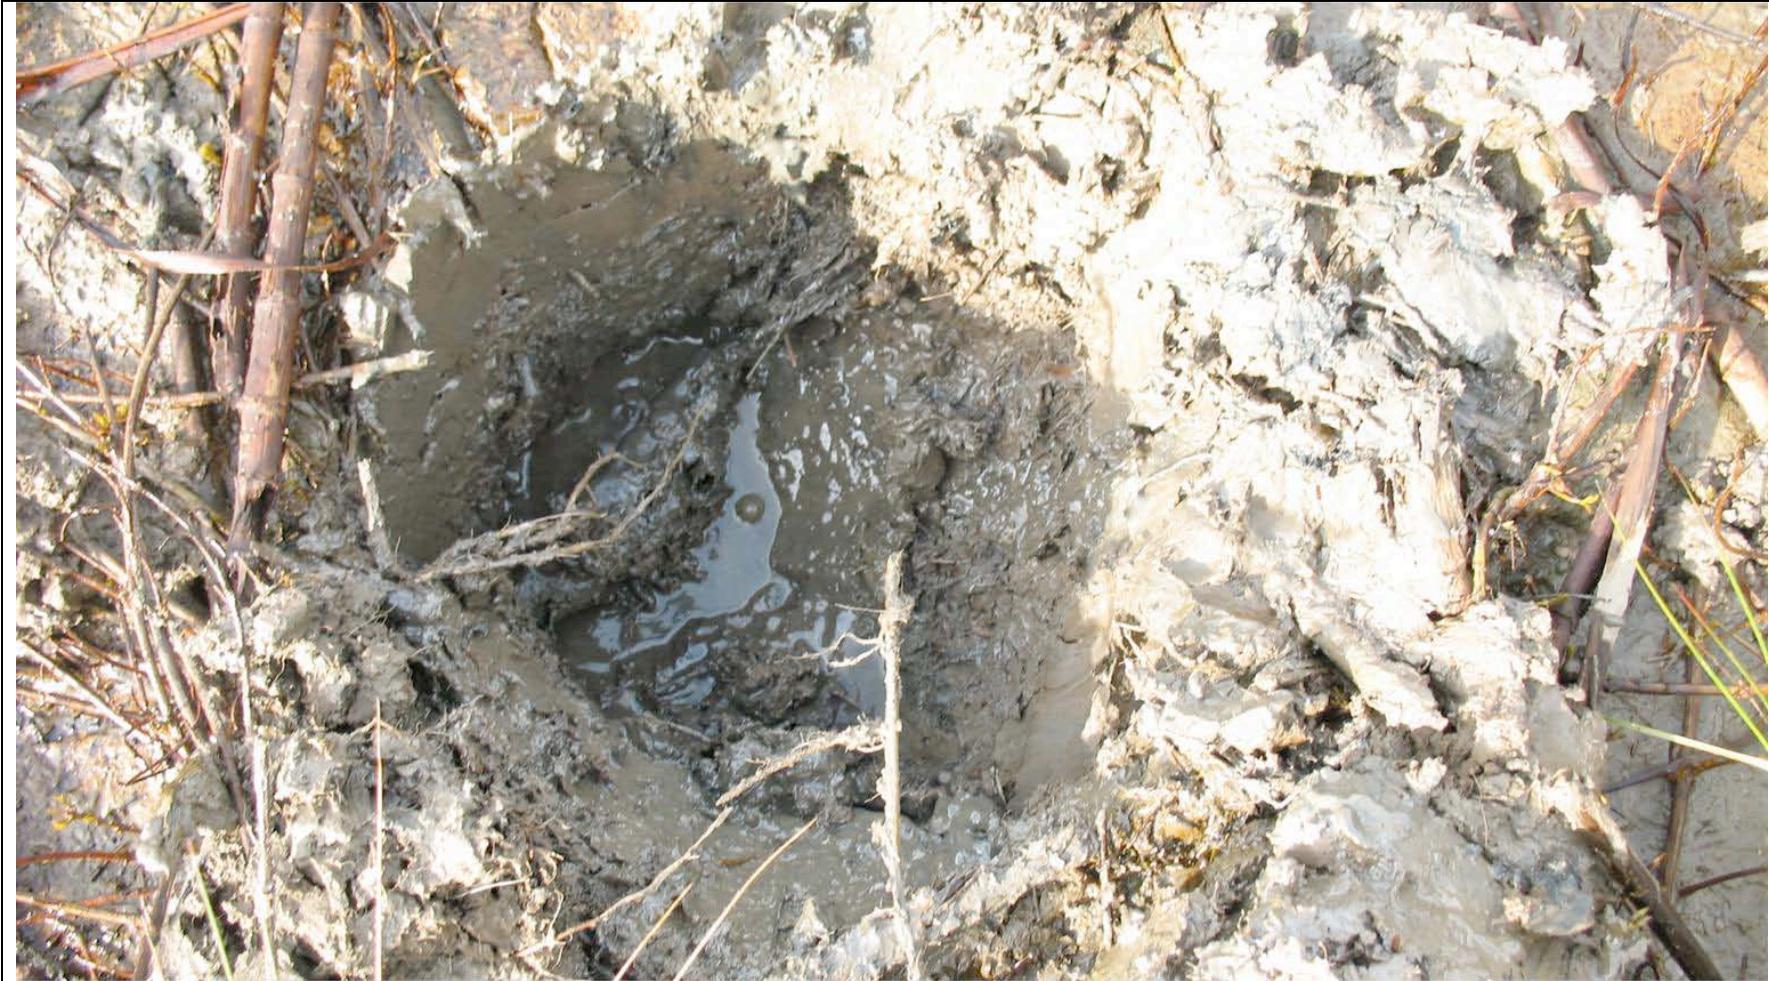
Photo #: 5 of 6

Description: (See site Z on Map #2) This hole was dug approximately 40' from the source at a depth of <1.5'. The photo was taken <1 minute (9:40 am) after the hole was dug using a spade and the sidewalls scraped with a gloved hand. Groundwater was observed draining from various veins through the sidewalls approximately 6"-8" from the surface. A peat-like layer of fibrous organics appears to exist below the clay/silt sediments.

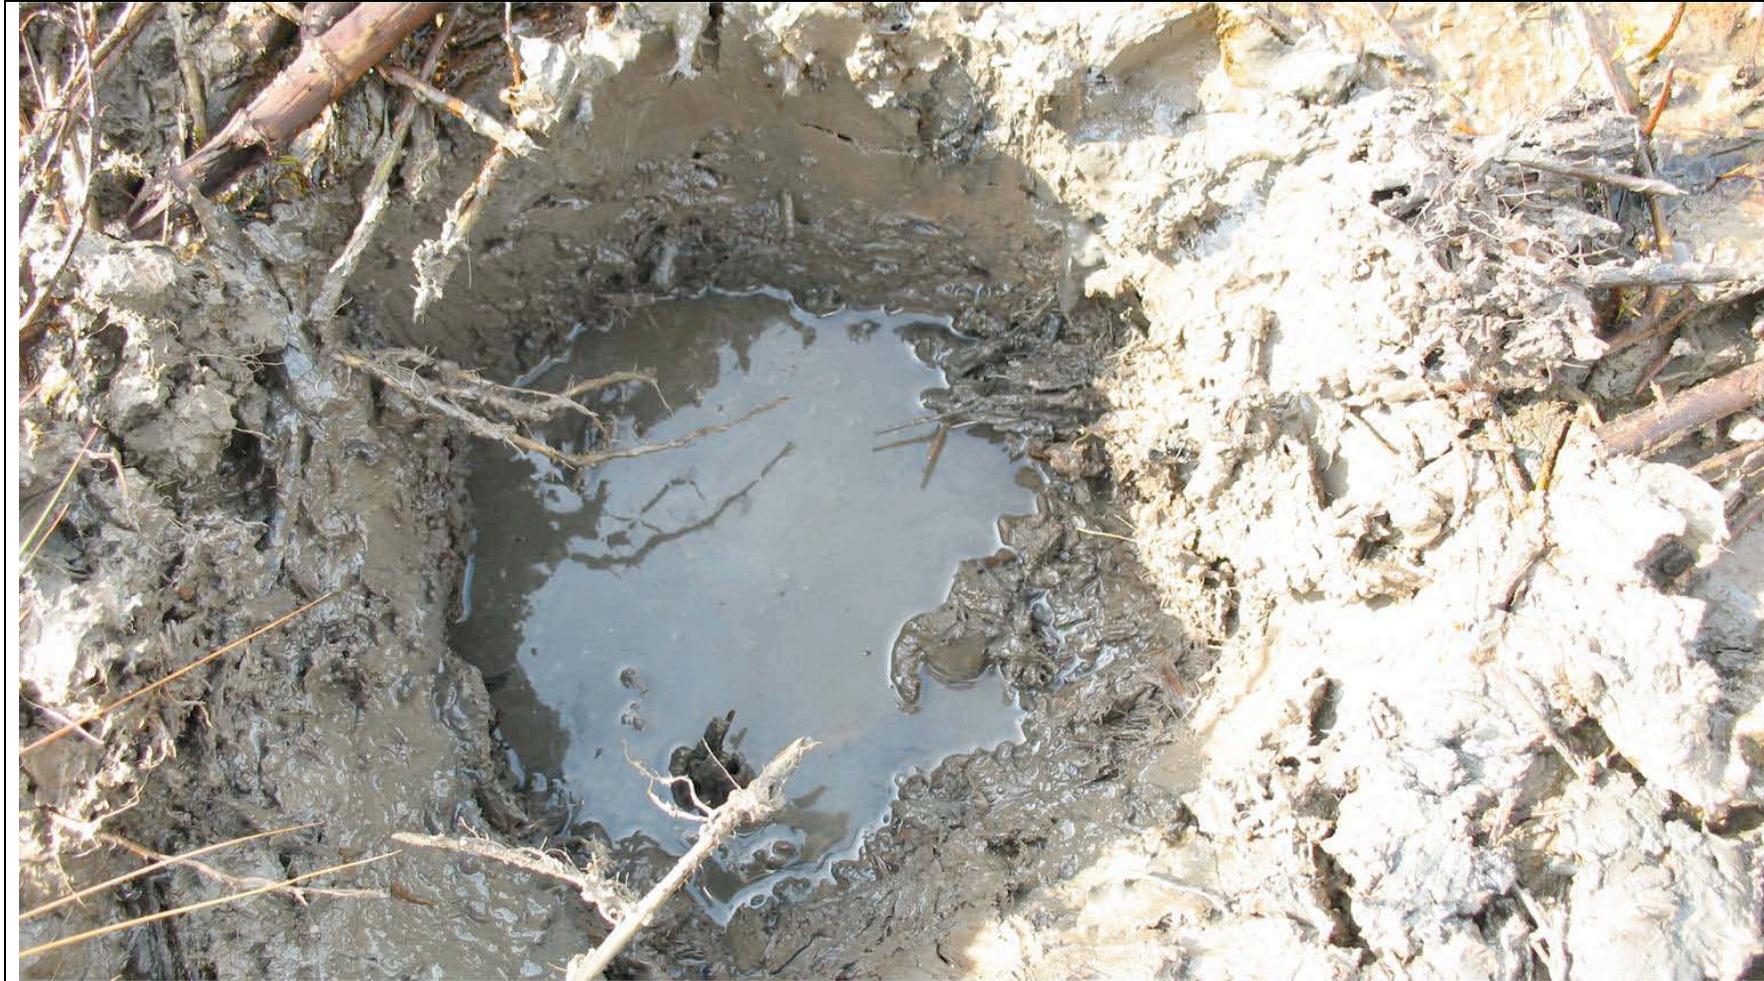
Photo #: 6 of 6

Description: (See Site z on Map #2) The same hole from photo #5, but the photo was taken <3 minutes (9:42) after the first. The bottom of the hole had begun to slowly fill-up with groundwater as it drained from various veins through the sidewalls and from the fibrous organic layer below. A sheen was observed on the groundwater, but it is unclear if the sheen traveled in with the groundwater or generated through contact with contaminated surface sediments that may have fallen in the hole.
