Yesterday there were conflicting and confusing reports coming in from Zone 4. New buried oil, oiled wrack and to what depth do you dig to. I went out to the site this morning. Yesterday they used a small bobcat excavator to work on digging up the oily patches in Ventana beach.

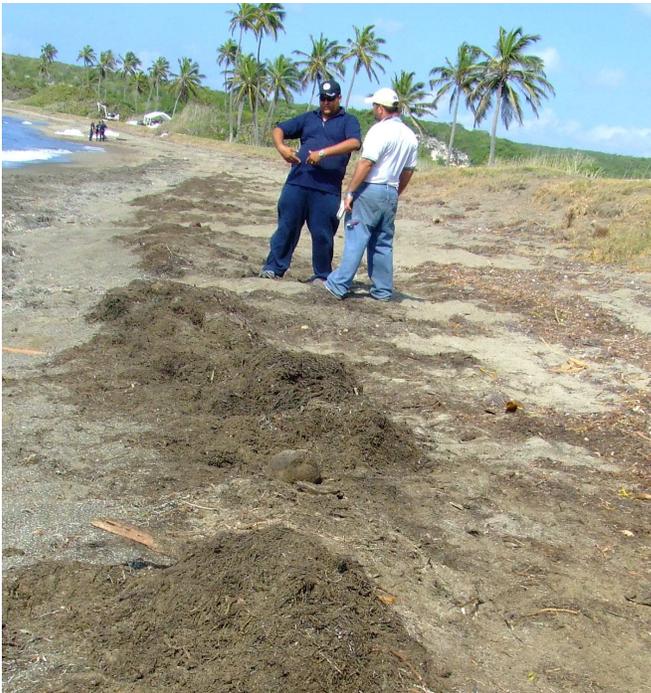
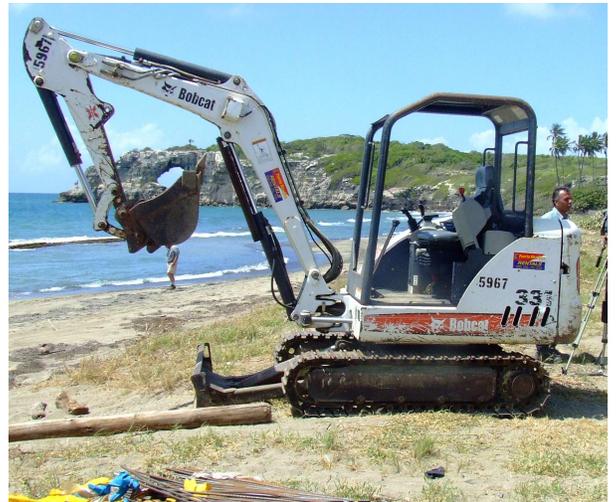
After some discussion and a quick sea turtle awareness talk to the clean up crews by DNER, work was resumed around 10:45 AM. There is an accumulation of oily wrack high on the beach at the far end of Ventana beach. I marked it to make it easier to identify and work. This needs to be removed today incase the sea turtles come back up on the beach tonight.

I checked the rest of the beach for oil. There are some pockets of oil stained sand but that was all I found except for those piles of oily wrack at the end of the beach.

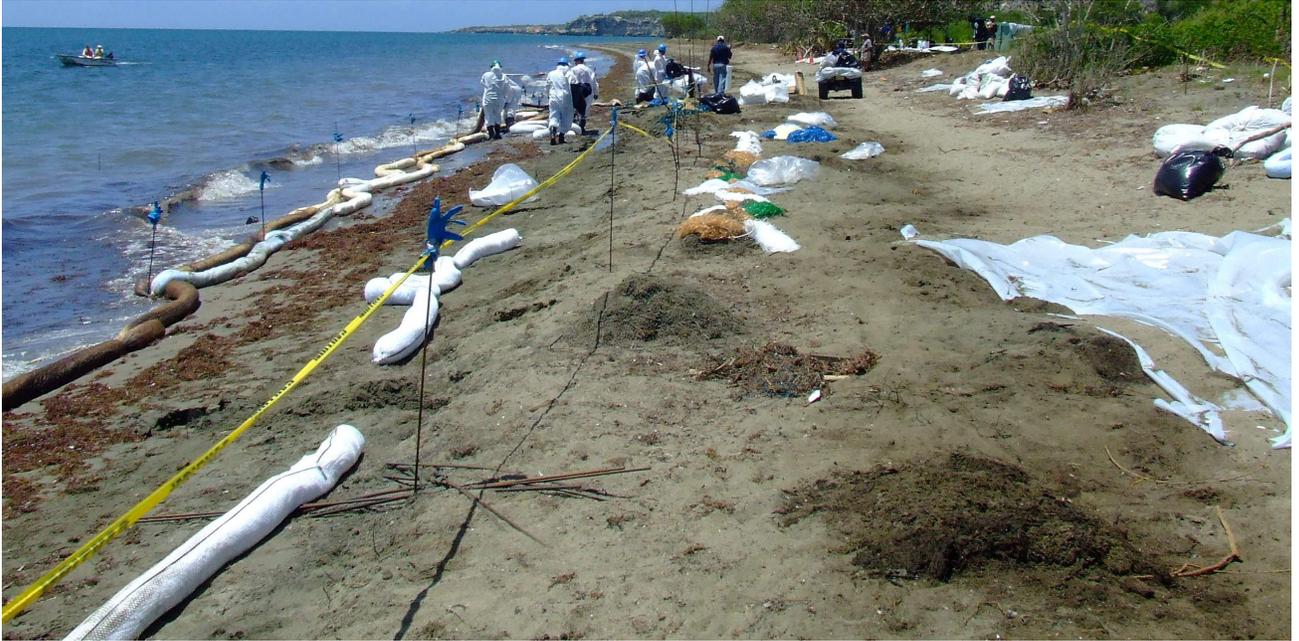
Majagua Beach 11 AM, Sept. 7, 2007. Note mounds of oily wrack at high water line need to be removed.

I think that the area of Majagua beach needs a thorough search for buried oil. I recommended that the excavator on Ventana be moved there to help. There needs to be enough boom in the water and regular boom maintenance to assure that the product does not move down to Ventana or to clean areas on Majagua. Hawksbill turtles are may also nest on this beach as well.

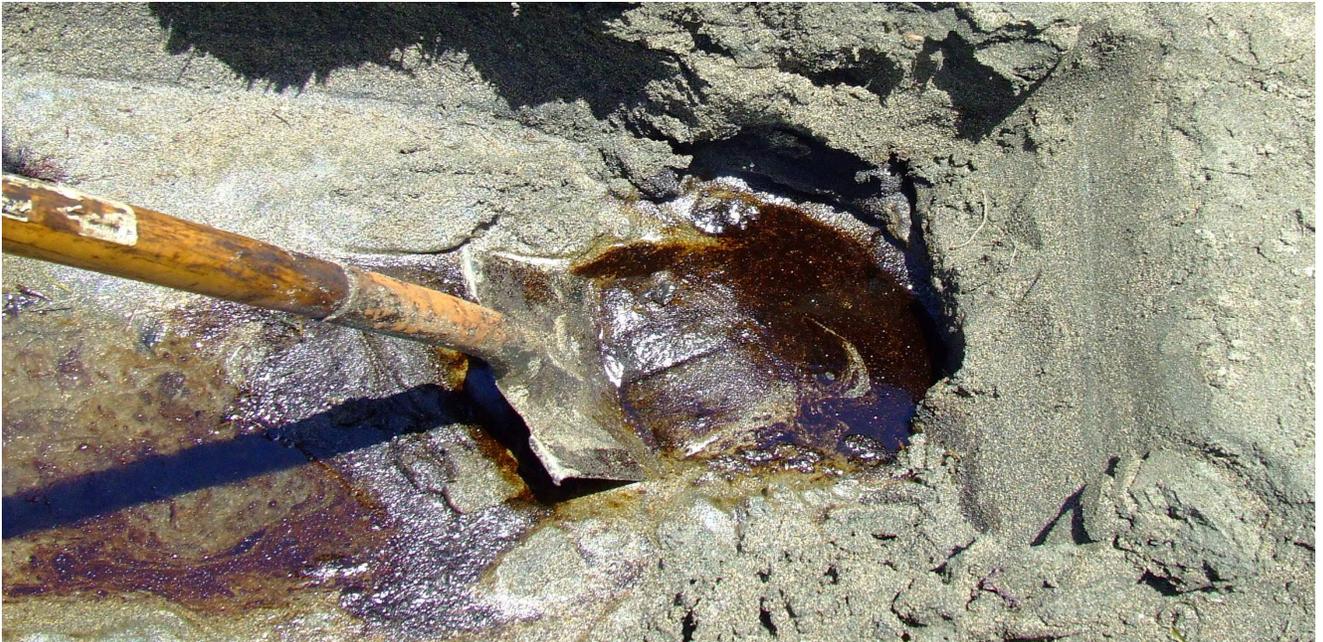
I got to Majagua Beach and it has problems, they found what seems to be buried liquid oil down near the low water line. It is buried some 12 inches or more in that find hard pact sand. Strike team was trying to better define the area. Booms were placed in the water but they may need additional layers of booms and they need to switch them out as soon as they get laden with oil. This material seems coat the outside of the sausage boom and once its coated the product does not penetrate easily.

Liquid oil buried at low water line Majagua Beach.

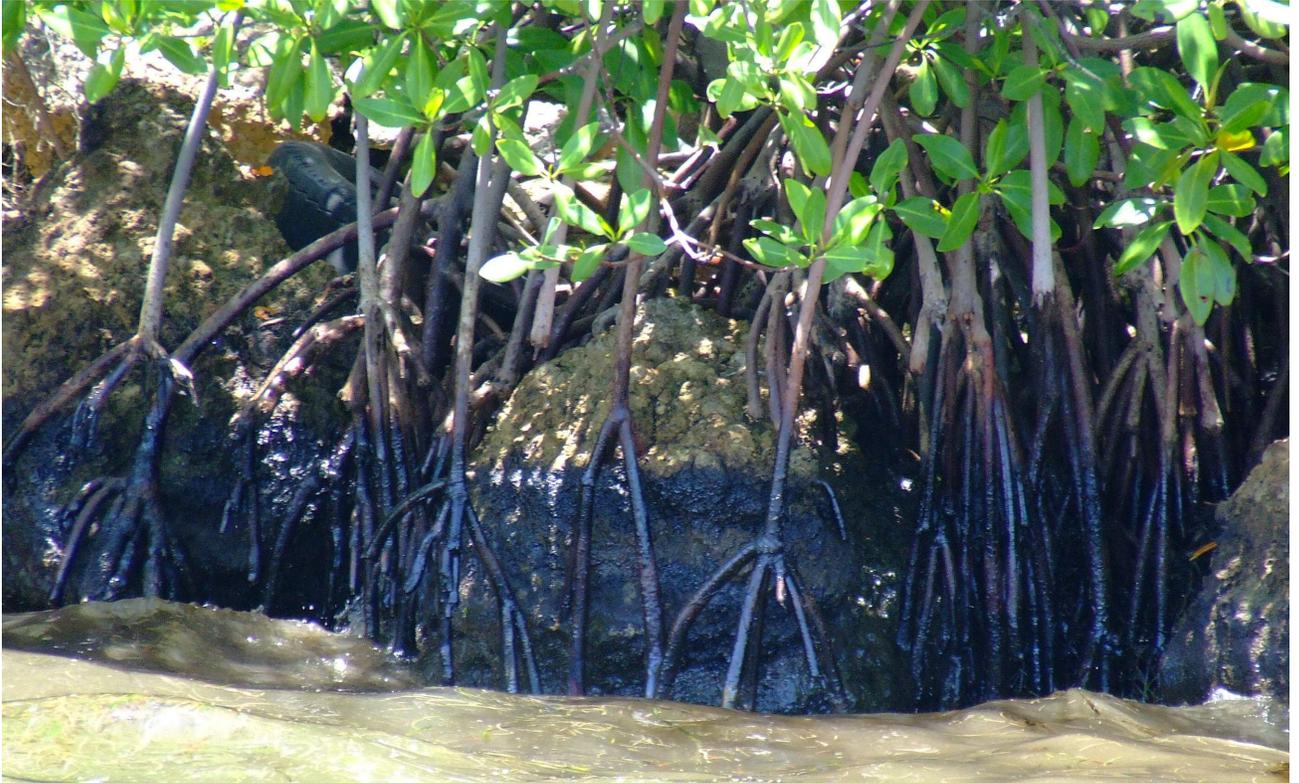
We then took a boat ride to another work site east of Majagua beach. There is no road access, so every thing is ferried in by boats. There are a series of sand beaches, mangroves and rocky shorelines that extend from just east of Majagua to the tip of Punta Verraco. One small work crew is working the more accessible areas. There are pockets of red mangroves with their roots heavily oiled, we did not get close enough to really check if the oil can be removed by passive cleaning with snare boom. Some of the mangroves had their lower branches covered in oil as well, leaving a bath tub ring effect.

Oiled red mangrove, you can see the black oil from the water line up to the first branches.

Some of these areas have an accumulation of oily wrack behind the mangroves, this needs to be assessed to see if it can be removed without causing further damage. In some areas there are black

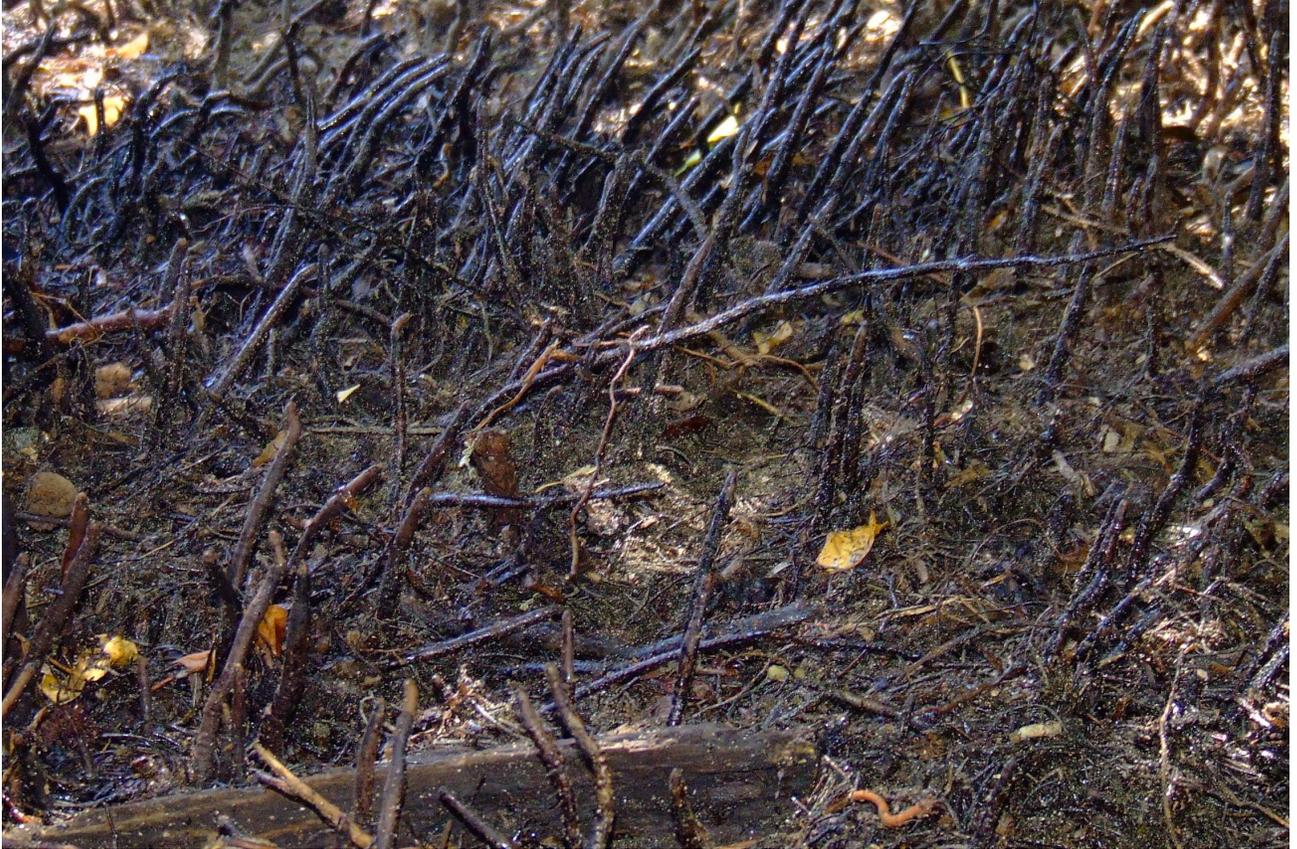
mangroves immediately along the shore. These have had their breathing roots also called pneumatophores coated with oil.

Black mangrove pneumatophores coated with oil. This is found in areas where black mangroves are found immediately behind the shore.

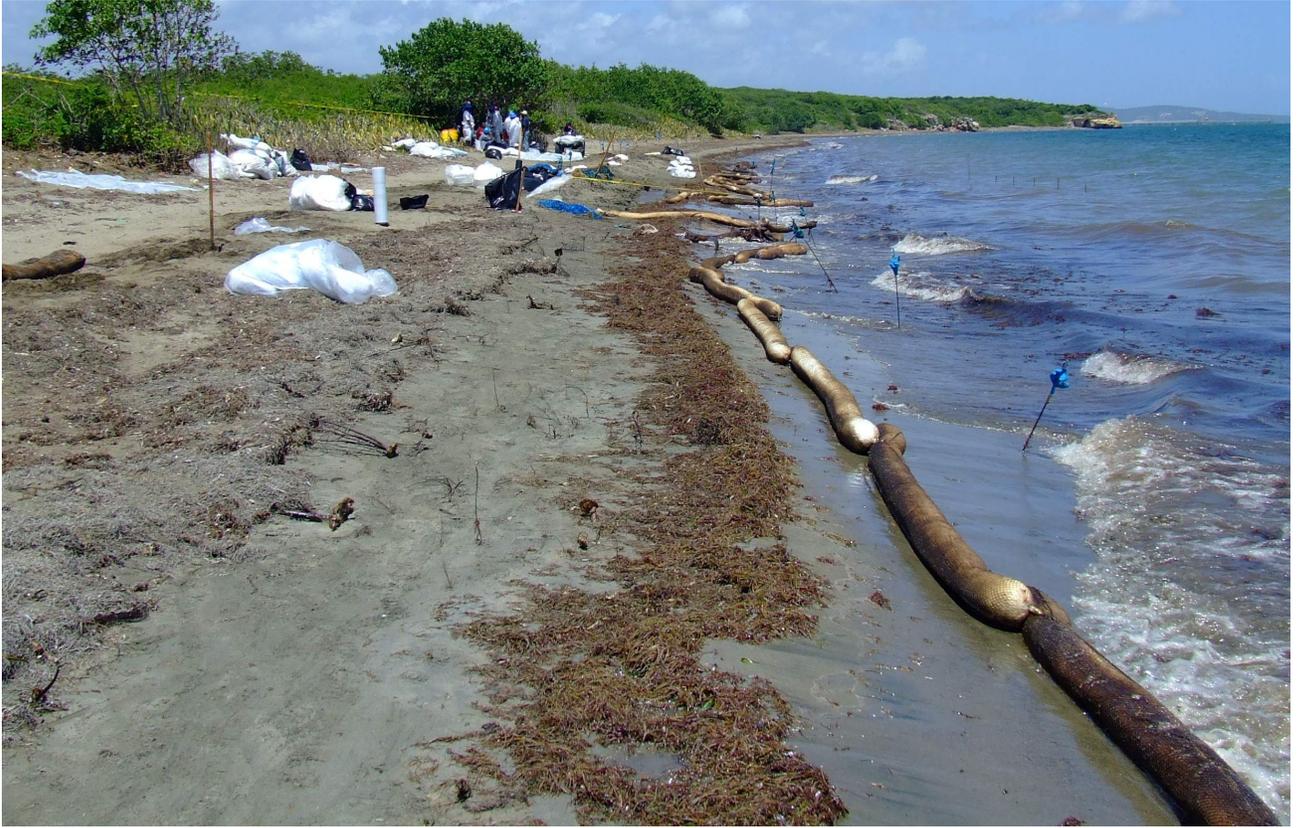
Majagua Beach clean up around 1:30 PM Sept 7, 2007
