## Tanker and Barge Collision in New Orleans, LA Update July 28, 1000 EDT

New Orleans DM932 Incident

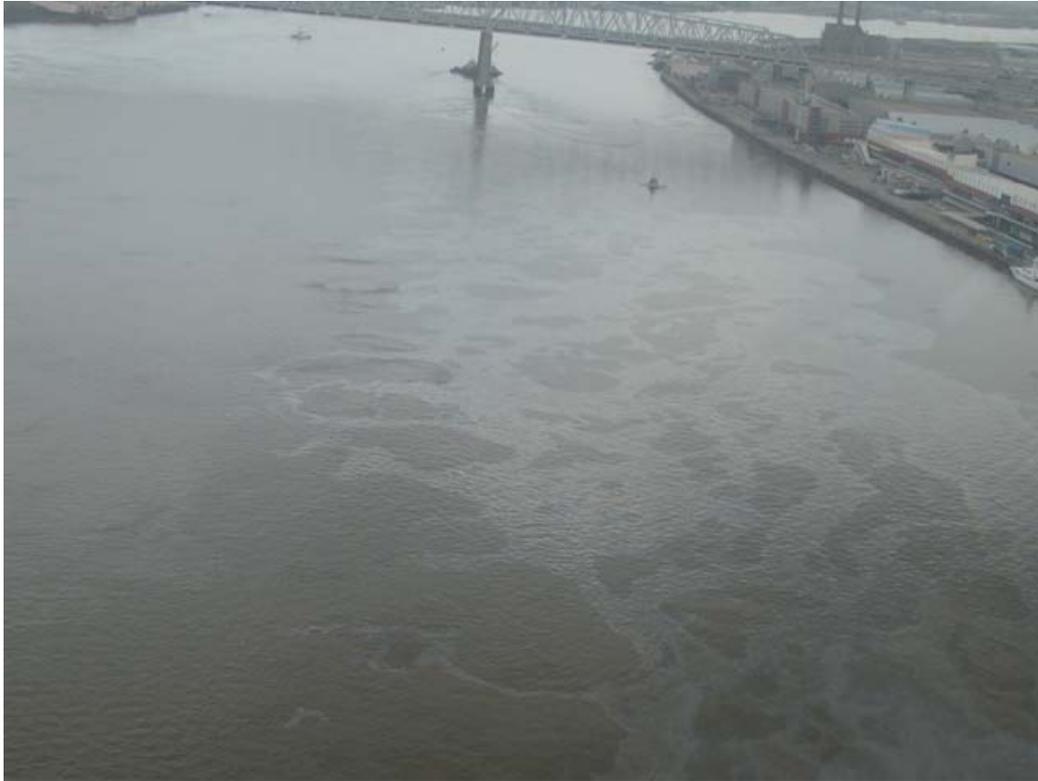
Oil continues to leak from barge against bridge. See oil skimmer in oil and ineffective booming. Current at 2-3kts. Afternoon overflight, 25July08. Photo by John Tarpley, NOAA.

- The barge is still adjacent to the Crescent City Connection Bridge in New Orleans and continues to leak small amounts of oil. Salvage efforts are focusing on stabilizing the barge to remove the residual oil. Once the pollution threat is removed, the barge wreckage will be removed from the river.

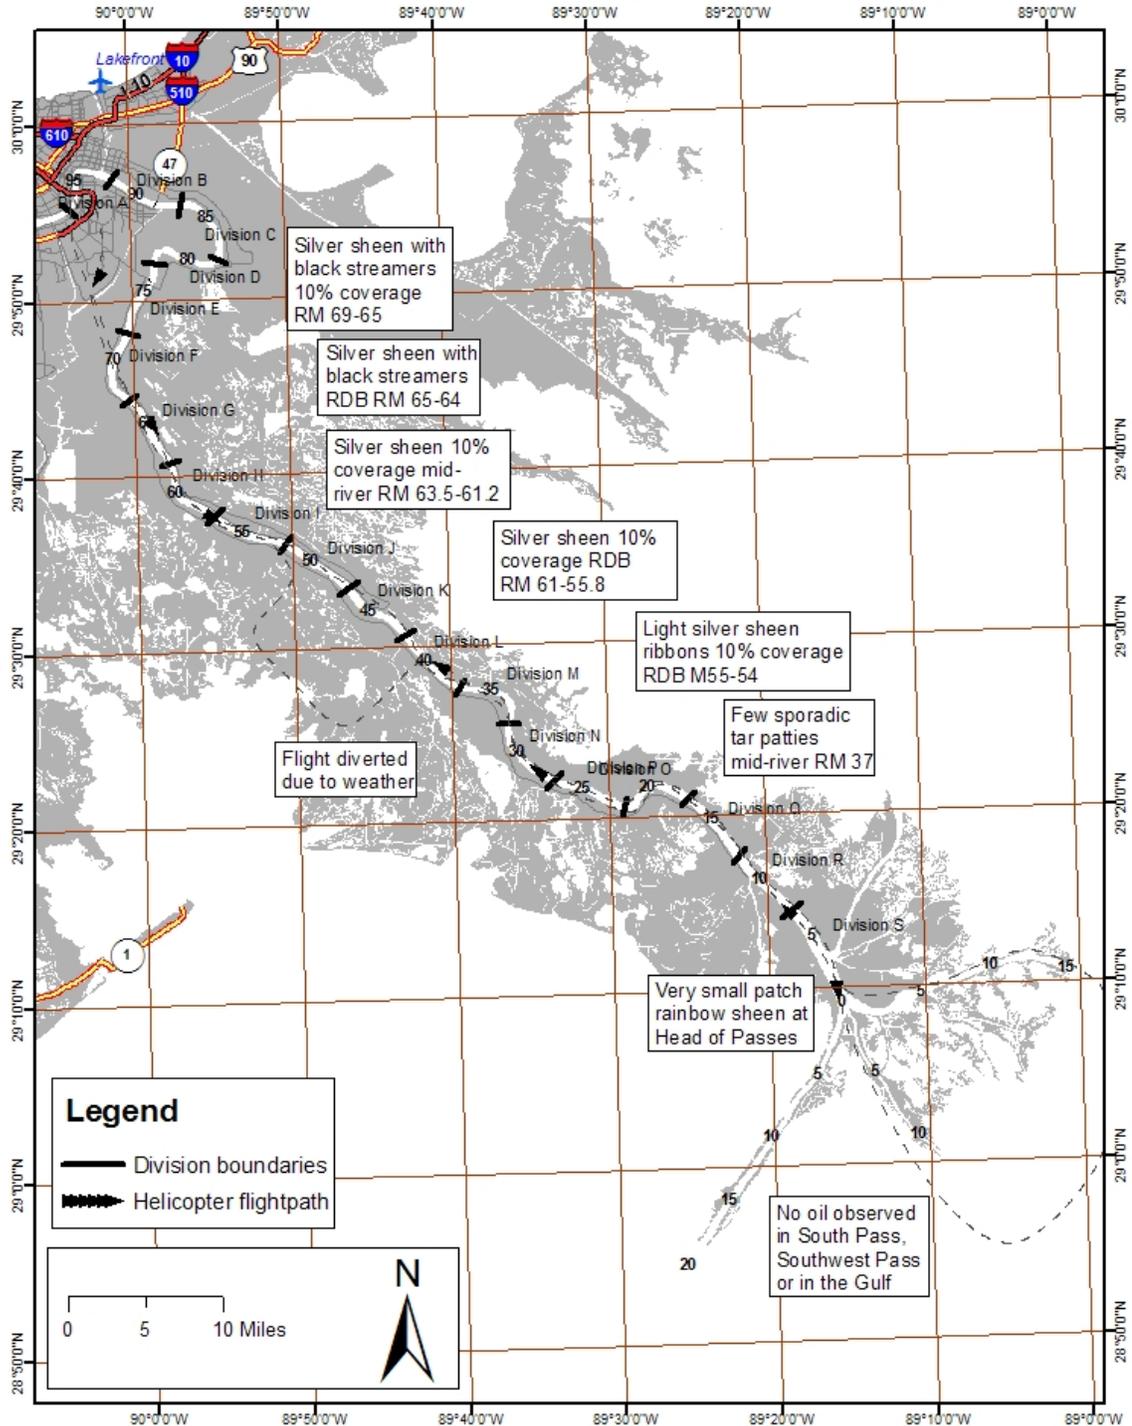
Overflight Map  
 prepared by NOAA  
 USE ONLY AS A GENERAL REFERENCE

- The majority of the spilled oil is stranded near the downtown piers and shorelines along a 50 mile section of the river below the City. Sheens and tar patties have been observed below the head of passes (See overflight map).

Overflight map from Sunday afternoon. Notes of oil observations are provided in text boxes, and the River Miles appear as points of reference. The spill occurred just north of the French Quarter near the River Mile 90 marker.

Date/Time: 27 July, 2008 1230-1500  
 Platform: USCG HH65 Helicopter  
 Observers: Travis, Weakley (USCG), McCall (USFWS)
